EXHIBIT A

Bishop – Tire Report

I was asked to examine a Dunlop D402 Harley Davidson, serial # DAF4 M17M 3107, rear motorcycle tire (subject tire), and to determine the cause of its failure. My observations and opinions are outlined in the following report. All of these opinions are based on my education, experience, training, skills, knowledge, and a review of the items and documents in this case. All of my opinions are based on a reasonable degree of scientific and engineering certainty.

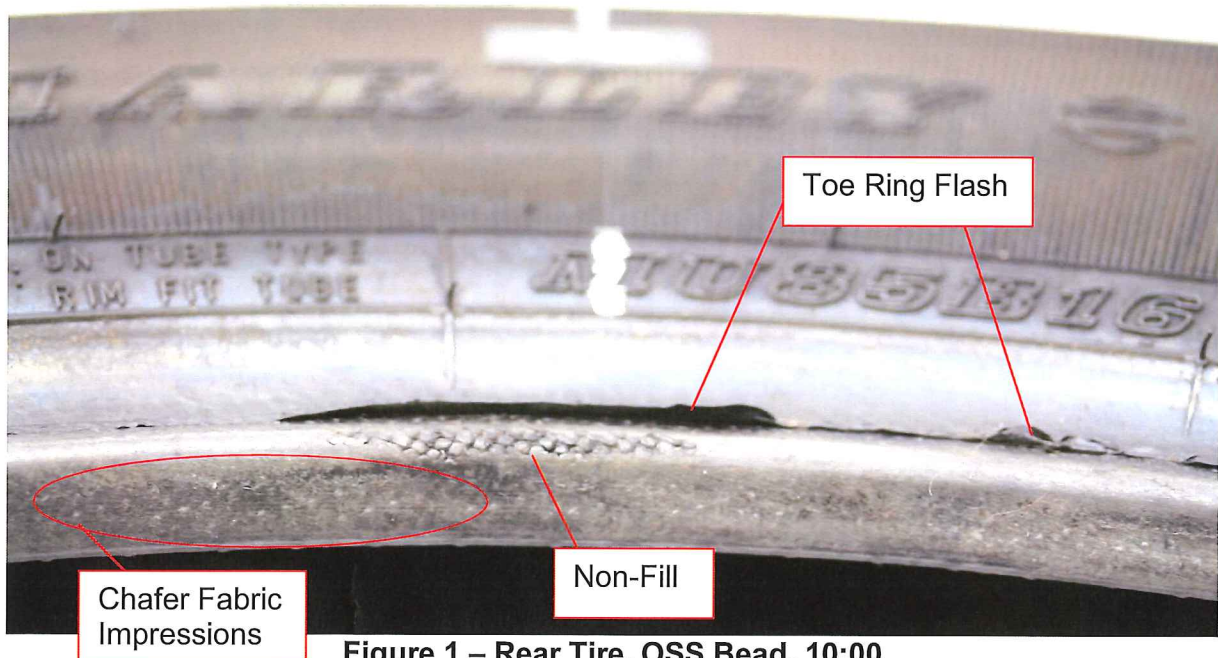
Figure 1 – Rear Tire, OSS Bead, 10:00

Upon demounting, it was discovered that there was very severe toe ring flash, at the mold junction, at numerous circumferential locations, along a ring located approximately 1/4" up the bead face from the bead heel on the SS bead. The flash widths reached 0.136", lengths reached 3.16", and thicknesses reached 0.006". This condition of toe ring flash compromises the air seal function necessary for a tubeless tire.

In both bead regions (SS & OSS), there were numerous places of medium non-fill, located primarily at the bead heel. A distinguishing feature of this condition is that it contains a series of uniformly spaced, circular beads of rubber, each with the appearance and approximate size of a head of a common pin. This corresponds to the density of the cross woven fabric in the chafer. The non-fill lengths reached 4.2" in the SS bead and 2.4" in the OSS bead. This condition of non-fill also compromises the air seal function necessary for a tubeless tire.

In both the SS and OSS beads, the impressions of the square woven chafer fabric were easily visible through the chafer skim rubber. This condition can also create a contributing factor in an unsatisfactory air seal in this region. These defects are shown in Figure 1.
